Algae

A Growing Problem for Lake Chatuge?

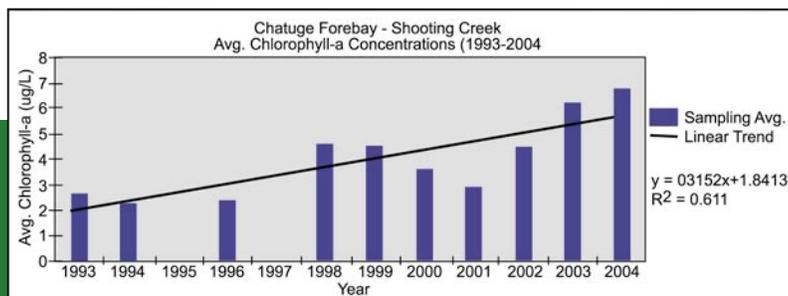
An increasing trend in algae concentrations (as indicated by chlorophyll-a measurements) has been observed in Lake Chatuge over the past decade.
